# CASE STUDY

*Rapid Identification of Fuel Nozzle Leak on CFM International LEAP Using the UL101 Aviation Troubleshooter (p/n B00033; Boeing Tool Tag SPL-1473)*

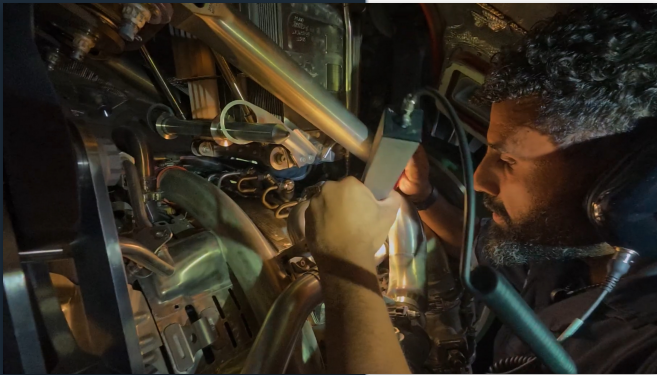
A 737 MAX aircraft returned a recurring fuel-nozzle leak fault code (80-44-005). This code indicates the FADEC does not detect adequate “trapped” fuel pressure within the manifold during engine start, suggesting that one or more fuel nozzles are leaking.

**The UL101 enabled techs to locate the leaking fuel nozzle in under 60 minutes.** No borescope was required, eliminating contamination risk and significantly reducing workload. **Rather than replacing all 18 nozzles (or all six nozzles on a single manifold), only the failing nozzle was replaced, preventing unnecessary parts cost and labor.** The process required no special certification; only attention to the differing amplitude of the ultrasonic signatures.
