# CASE STUDY

*Pinpointing a Nitrogen Leak in a Boeing 777-300ER Nose Landing Gear with the UL101 Aviation Troubleshooter (p/n B00033; Boeing Tool Tag SPL-1473)*

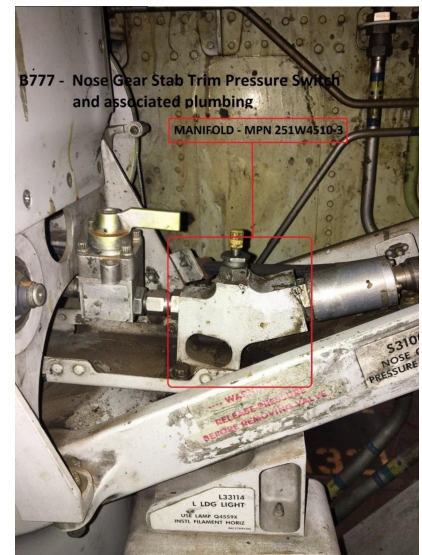
No leaks could be found, so all components associated with the stabilizer trim pressure switch and plumbing were replaced (refer to Boeing IPC 27-48-04-01 and attached photo).

Using the UL101 Aviation Troubleshooter, the complete stabilizer trim pressure switch and plumbing system was investigated. An air leak was found with the manifold assembly. This part had been previously replaced to rectify the fault and therefore was determined to be defective from stock. A replaced part being the source of the leak was unexpected, and without the UL101's ease of use, it would not have been easily found.

Although the aircraft experienced extended AOG downtime, the operator found and confirmed the defective part as the cause of the leak by using the UL101. This saved further troubleshooting time and eliminated the need to ask the operator's specialist Landing Gear technicians from its home base in another state. The fault was rectified, keeping the aircraft from further delays.
